## BEST Center Funded Research Summary

# Evaluation of Field Methods for Assessment of Architectural Window Degradation

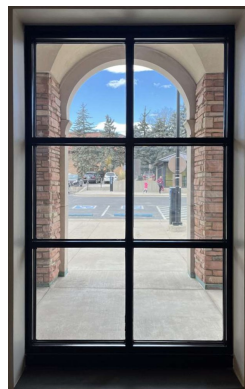
**Figure 1.** IGU on CU Boulder campus being evaluated for performance reduction due to degradation.

Measurements using the hybrid field testing method on a window on CU Boulder campus, shown in Figures 1, 3b, and 4, demonstrate the method is capable of measuring IGU emissivity (0.83) and U-value (1.53 W/m<sup>2</sup>-K) comparable to the manufacturer's reported values (1.59 W/m<sup>2</sup>-K). Uncertainty analysis of the hybrid method demonstrated U-value uncertainty of  $\pm 0.27$ -0.3 W/m<sup>2</sup>-K. Window indoor-outdoor temperature differential and wind speed significantly influenced measured U-values.

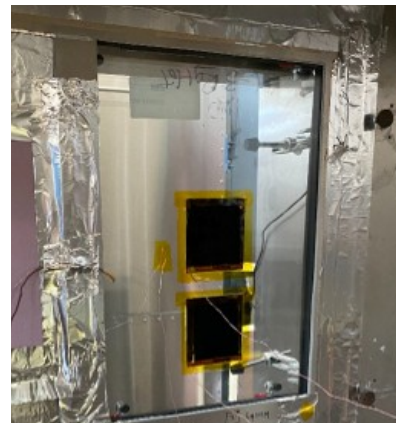
Shown in Figure 2 is a lab-based validation of the sensitivity of the proposed hybrid field testing method. Using four samples with a known U-values (low-e argon fill, low-e air fill, clear argon fill, clear air fill), testing was conducted for 10 hours with three different temperature differentials ( $\Delta T=10, 20, 30$  °C). Errors in U-values using the hybrid field method, compared to the known U-value, were lowest when measured with a  $\Delta T$  of 10 °C, ranging from -2.8 to 1.7%. Measurement error had increasing negative bias as  $\Delta T$  increased, with errors ranging from -10.3% to -4.1% at a  $\Delta T$  of 30 °C.

**Figure 2.** U-value field testing method validation using NLR IGU test chamber.
