## BEST Center Funded Research Summary

# Evaluation of Field Methods for Assessment of Architectural Window Degradation

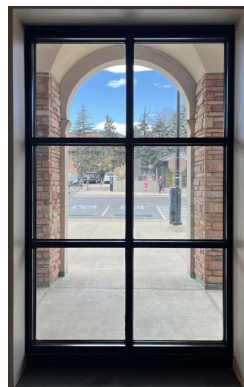
*Figure 1. IGU on CU Boulder campus being evaluated for performance reduction due to degradation.*

Measurements using the hybrid field testing method on a window on CU Boulder campus, shown in Figures 1, 3b, and 4, demonstrate the method is capable of measuring IGU emissivity (0.83) and U-value (1.53 W/m<sup>2</sup>-K) comparable to the manufacturer's reported values (1.59 W/m<sup>2</sup>-K). Uncertainty analysis of the hybrid method demonstrated U-value uncertainty of  $\pm 0.27$ -0.3 W/m<sup>2</sup>-K. Window indoor-outdoor temperature differential and wind speed significantly influenced measured U-values.
